FARM SHOW

Money-Saving Repairs & Maintenance Shortcuts

Simple Repair Kit Solves Case IH Combine Problem

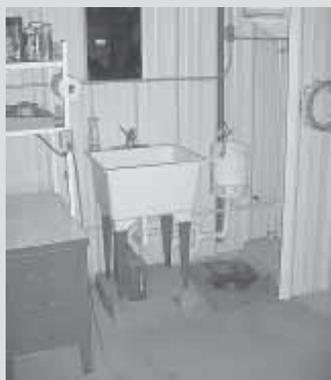
as two wash-up sinks. I installed a urinal that I made out of a 5-gal. bucket next to one of the sinks. A sink drain fixture attaches to the bottom of the bucket, and a shower head

mounts at the top to flush it out. I use a valve handle attached to the shower head to release a shot of water."

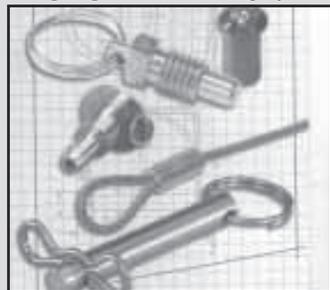
a wide variety of non-threaded fasteners including clevis pins, detent clevis pins, lynch pins, wire lock pins, tab lock pins, detent ring

pins, positive lock pins, pull pins, ball plungers, ring pins, bent arm pins, and headless pins. We also offer steel and nylon lanyards, bulk cable, bulk terminals, cable cutters and crimp tools, press lock rivets, bow-tie locking cotters, rue ring locking cotters, hair pin cotters, and infinity S-hooks. We sell to some catalog sources and many OEM's and are continually researching and developing new fastener solutions.
