Don't Toss That Defective Digital Display; He'll Fix It!

Waterjet Cutting System Designed For Farm Shops

Cab Mounted On Kubota Tractor

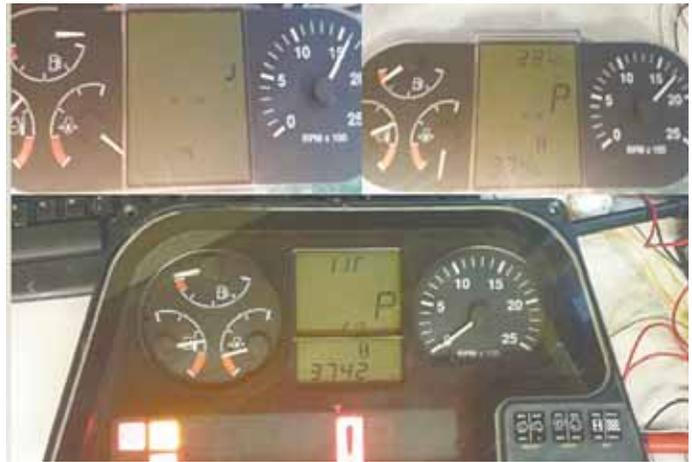
Before (top 2 photos) and after (bottom photo) repair of White 8510 tractor gauges. Gauges would sometimes not work or missing pixels would appear on the display.

Ditz was able to fix about 98 percent of the problems. He found a common problem was a corrupted EPROM or flash file caused by a battery boost to a dead battery. Other problems include failure of cold solder joints and ribbons to bad chips, microprocessors failing, or defective plastic stepper motors that drive the gauges.

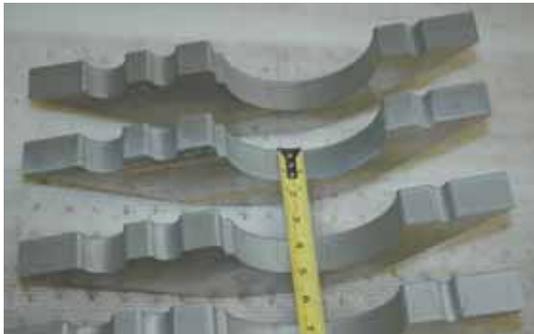
These 1 1/2-in.-thick titanium parts were cut at a speed of 3/4 in. per minute with the FARM-JET cutting system. The machine can cut material up to 5 in. thick.

flow and 55,000 psi pressure at the tip of the abrasivejet cutting head. Material lays on a 40-in. square cutting table and is cut as the head follows a computer-generated cutting path. The head is mounted on a motorized Z axis with 5 in. of up and down travel. Side-to-side and front-to-back movement is controlled by the X and Y axis.

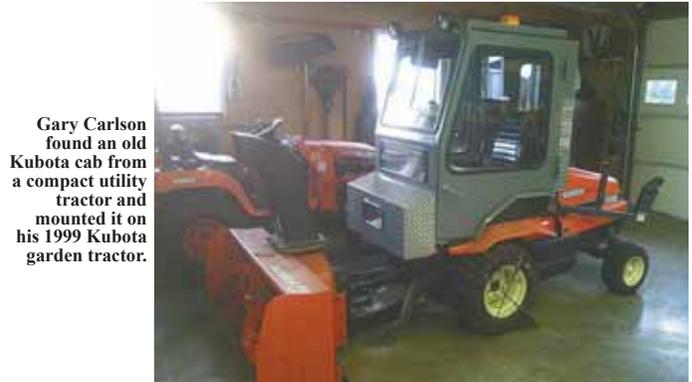
Gary Carlson found an old Kubota cab from a compact utility tractor and mounted it on his 1999 Kubota garden tractor.

The cab was taller than necessary for the mower so they cut 10 in. off the bottom. In order to accommodate the steering column they also lengthened the cab by 6 in., welding new sheet metal onto the back side.

A diamond plate box was added on front of the cab to accommodate the mower's foot controls, including the hydrostatic foot pedal, brake pedal, and differential lock which extended in front of the steering wheel. "We fabricated some aluminum parts and attached them over a steel frame that attaches to brackets, which we mounted on the mower's chassis," explains Todd.
