“BRIDGING” CAUSES 20 BY 80 FT. HARVESTORE TO TOPPLE

Midnight Silo Crash Creates Excitement

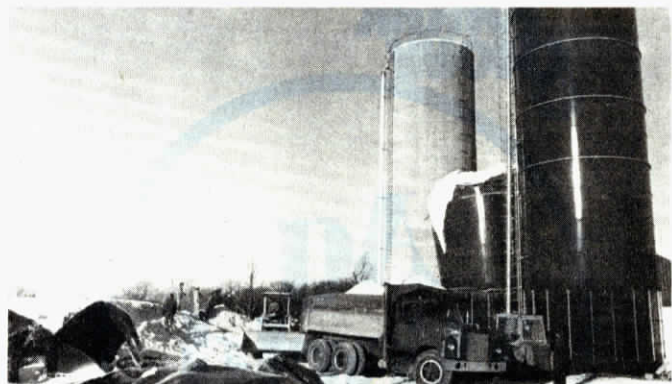
Lancaster Farming Photo

Toppled Harvestore (center) was replaced by the company within five days.

McLean, what caused the silo to fall was a phenomenon known as “bridging.” He explained that the ground high-moisture ear corn, which is a semi-free flowing material, created a shifting pattern in the feed inside the silo due to uneven unloading.

“The internal load shifted and put stress on the structure,” McLean said, pointing out that this is the first case of its kind experienced by Penn-Jersey in more than 1,500 silos the company has constructed.

What is presumed to have happened is that while the Kralls were unloading the high-moisture corn, a gap in the feed layer was created — leaving a bridge potentially eight tons wide between the suspended feed layers. When the upper layer finally dropped down, a vacuum sucked the airtight Harvestore’s panels in, causing a buckle about 15 ft. off the ground. The pressure of the shifted weight-load on the panels eventually caused the silo to split and fall to the ground.

Five days after the mishap, Penn-Jersey had a brand new, 20 x 80 Harvestore standing where the one-year-old structure had been. And the silo company replaced Krall’s ground ear corn with high-moisture shelled corn.
